Uncertainties in Subsurface Characterisation For Building Construction: Case Studies of Two Site Investigations in Lagos Metropolis

Olagunju, K.T.¹, Olobaniyi, S.B.¹, Oyedele, K.F.¹ and Adefuwa, A.¹

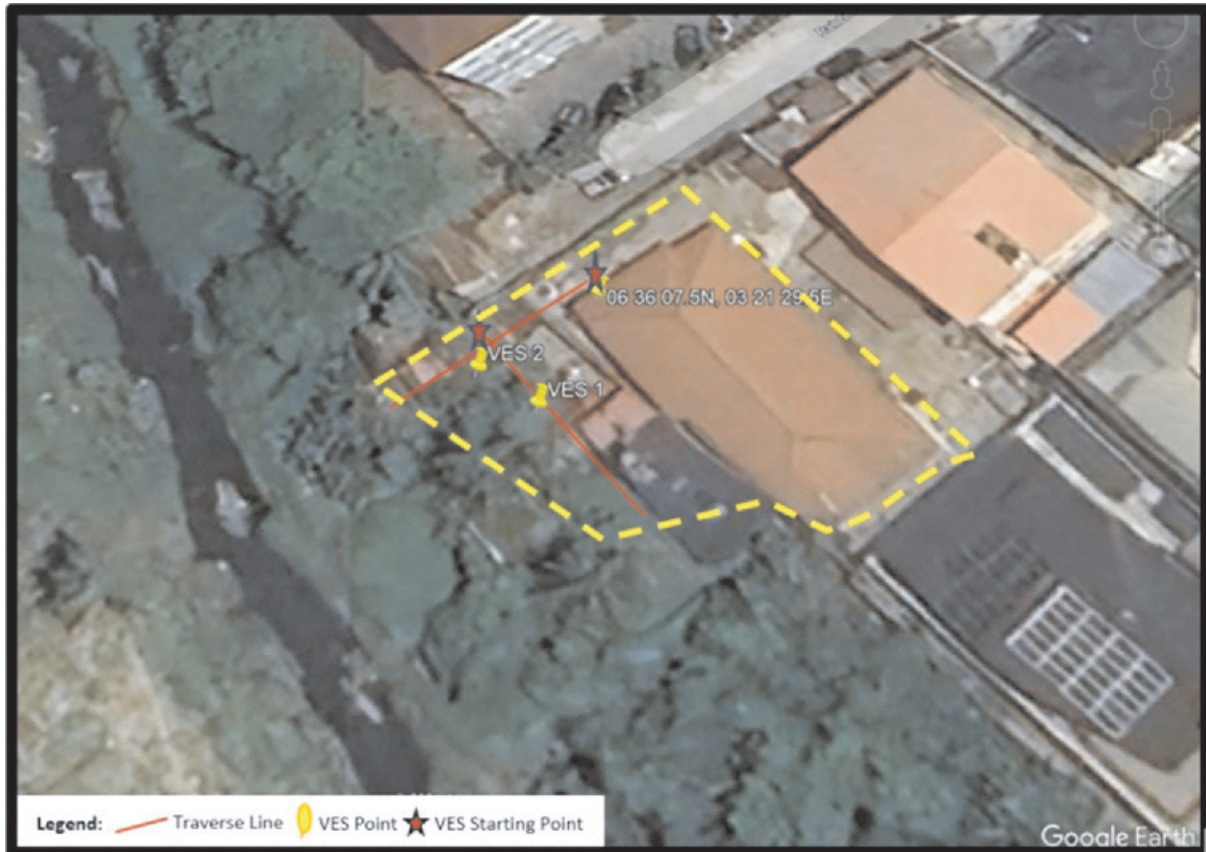
Fig. 2: Data Acquisition Map of the Study Area (Site A)

characterize the geotechnical boring, to investigate possible lateral occurrence of the deep-seated ironstone that rendered the borehole test inconclusive. Two profile 2D resistivity survey and vertical electrical sounding were used for this purpose of delineation of the ironstone as shown in Figures 2 and 3 below.

acquisition map of the area showing the 2-D traverses and VES points and a picture of data acquisition in progress at Site A.

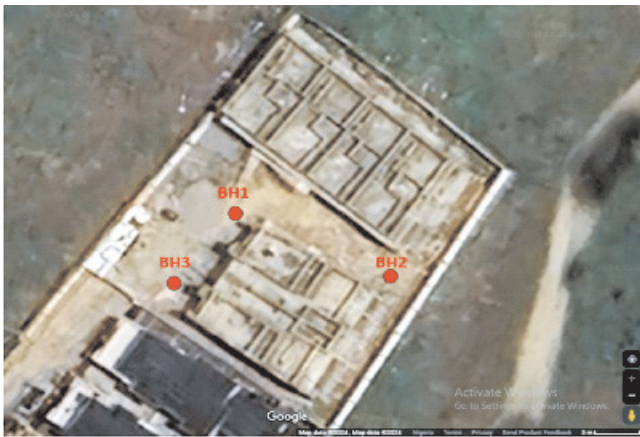
Fig. 4: Distressed building on pile foundation (under construction) and distribution of boring test (Site B).

were carried out on Site B (forensic study). Figure 4 shows the location of the building under construction on Site B and the environs, characterised by swampy terrain.

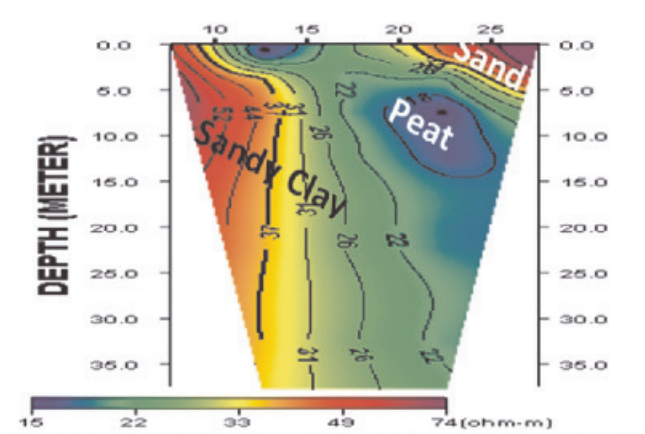
Fig. 6: 2D Resistivity Imaging across Profile 1

Figure 6 represents the 2D resistivity imaging along profile 1. From the 2D resistivity pseudo-section, three (3) geoelectric layers were delineated which include the topsoil, peat/sandy clay and sand/sandy clay/clayey sand. The resistivity of the section varies between 15 Ωm – 74 Ωm and penetrates to depth of 35 m. The 2D result showed that the sandstone beneath the proposed site is not continuous and could terminate at depth below 25 m. The sandy clay/clayey sand was delineated toward the left-hand side of the pseudo section.

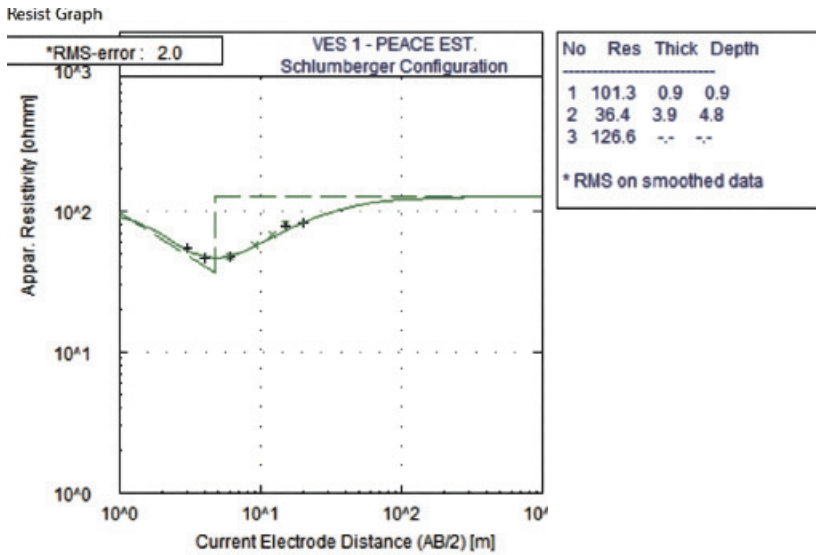
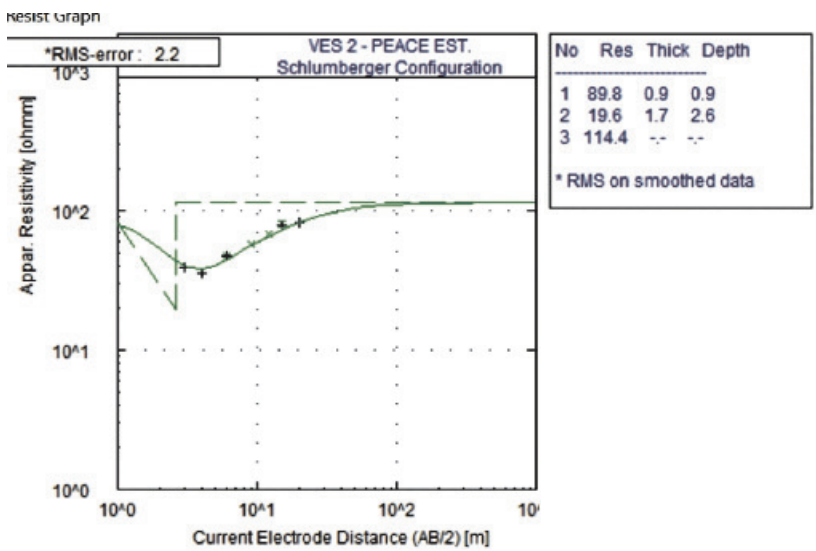
The VES results are presented as 1-D resistivity sounding curves as showed in Figures 8 and 9. The curves were interpreted qualitatively and quantitatively. Quantitative interpretation of the curves involves partial curve matching using two layers Schlumberger master curves and the auxiliary K, Q, A and H curves. The qualitative interpretation reveals A curve type.
